NGA GLASS CONFERENCE CARLSBAD

Update: Natural Disasters, Building Resiliency, Building Codes & GLASS

Thom Zaremba Roetzel & Andress NGA Fire & Structural Codes Consultant

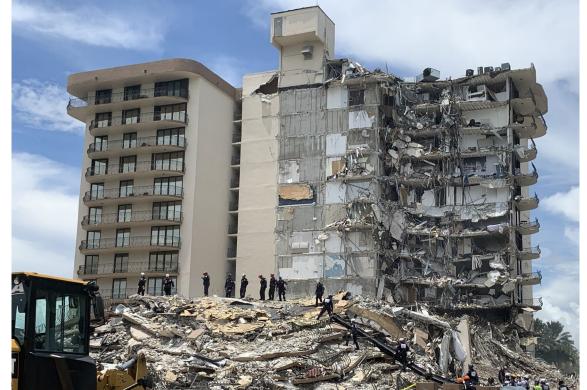
The site of the Champlain Towers South partial collapse in Surfside, Florida. <u>Credit: NIST</u>

1. June 24, 2021 - Collapse of 55 out of 135 units in a 12-story high rise condominium in Surfside, Florida.

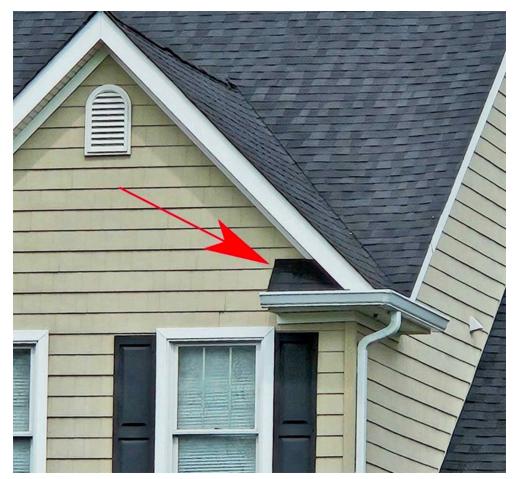
What would a home designed to survive a wildfire look like?

- It would have exterior glass that is tempered which is ember resistant

or even BETTER - fire-protection rated glass that won't fail from ember strikes, extreme radiant heat of even direct flame.
- No eves with nooks that can catch and trap flying embers.

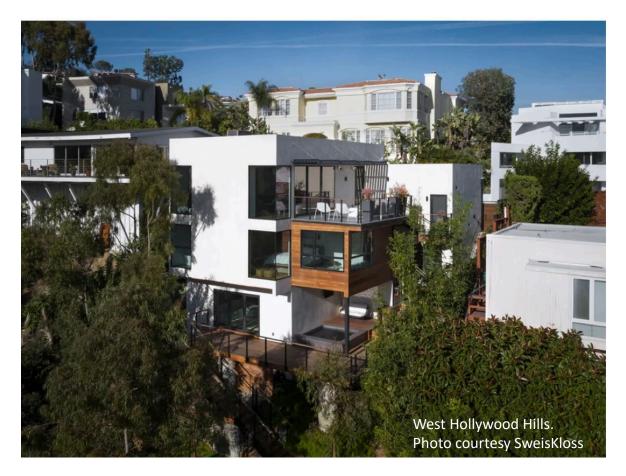
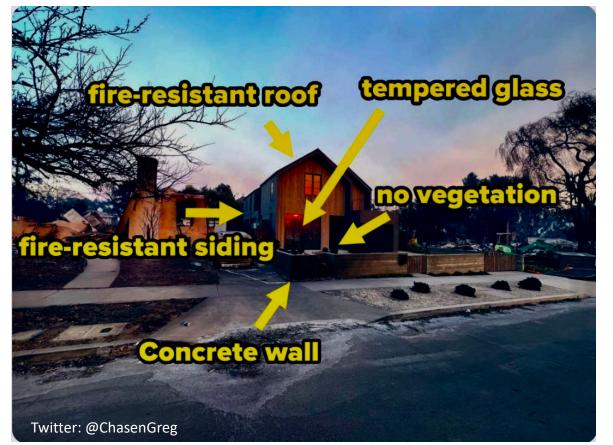
It would look like this home that survived the Palisades fire in California!

Please note that a number of the tempered glass windows did NOT survive the fire, making its exterior windows the weak link – they should have been fire-protection rated!

- It would also have a roof made with a Class A rated roofing material, i.e., usually steel, asphalt fiberglass composition shingles, concrete or flat/barrel-shaped tiles.
- Its exterior walls would be made from ignition resistant and/or fire-resistant materials too. These can include concrete or steel, but one or more gypsum drywall layers is the most common fire-resistant interior finish.

It would also be surrounded by a "defensible space" free of plants, shrubs, and flammables and constructed using a lot of concrete.
